ROADPROOF ROLLING FAILED ROAD FORMATION, PT NOARLUNGA, S. A.

RIVER ROAD

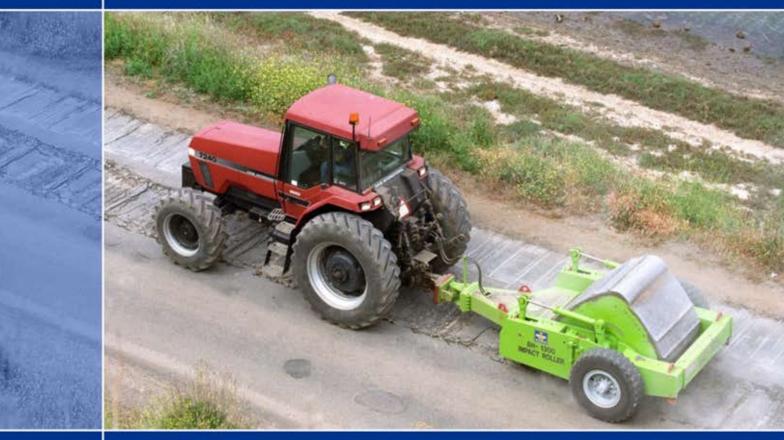
City of Onkaparinga
Port Noarlunga, South Australia (Australia)
BH-1300 (8t module)
Subgrade failure was caused by a combination of increased heavy traffic volume, poor compaction & close proximity of Onkaparinga River.
One lane was treated with the Impact Roller at a time to allow the road to remain open, objective was to increase in-situ densities to minimise the future risk of subgrade failure.
Settlement in excess of 150mm was achieved with 20 passes. Demolition of the asphalt pavement breaking was a secondary benefit, allowing for the recycling of the material.
