# GROUND IMPROVEMENT OF LANDFILL SITE USING THE “SQUARE” IMPACT ROLLER

## ABSTRACT

## 1 INTRODUCTION

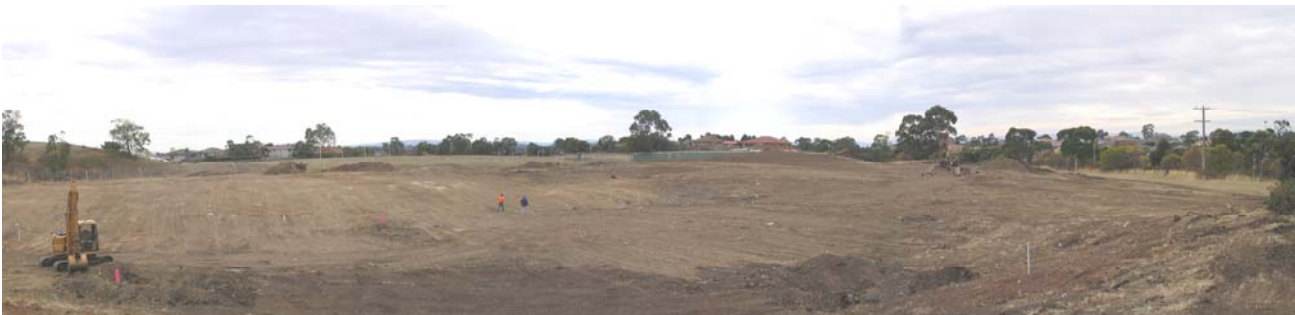
Figure 1. Panorama of depressed central area during preliminary site stripping.

Basalt had been quarried to the deepest depth in the central third of the site, and this area had been filled with refuse, observed to be about 3-4m thick, and capped with 2-3m of quarry overburden. Most of the site was covered with reworked quarry overburden, comprising silty to sandy clay with fragments of basalt. Significant settlement had occurred in the central part of the site, indicating the zone of buried waste (see Figure 1).

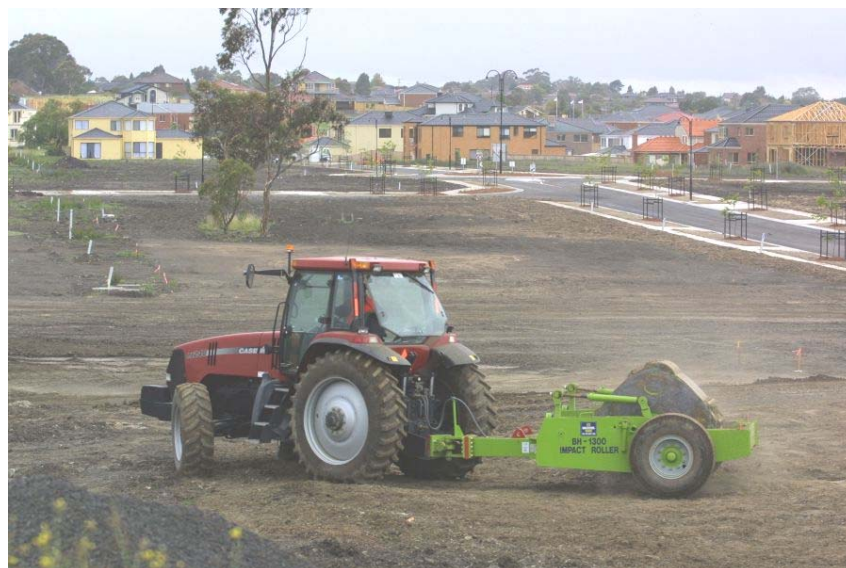
Figure 2. Impact Roller at a Melbourne residential development site.

The option finally approved comprised the stripping and stockpiling of most of the existing capping over the refuse (leaving a minimum cover of 0.5m so that waste was not exposed at the surface) and the use of rolling dynamic compaction, or impact rolling, to densify the fill material. Impact rolling was accomplished using an 8t non-circular (4-sided or “square”) module towed in a frame by a 4-wheel drive tractor, a technique utilised for various applications around Australia for 20 years (Avalle 2004) (as illustrated in Figure 2). The work was carried out under an environmental management plan (Coffey Geosciences, April 2004).

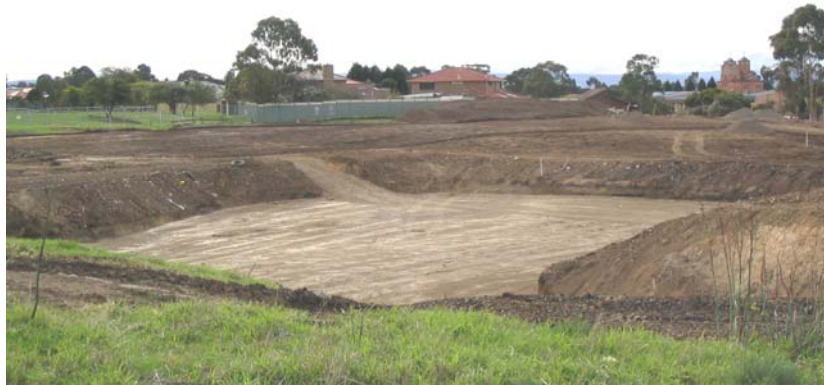
Figure 3. After excavation of the former capping over the refuse, prior to impact rolling.

After accurately delimiting the extent of refuse fill utilising all previous data and additional trial pits, capping material over the refuse was excavated and stockpiled, leaving a minimum 0.5m cover over the waste (see Figure 3 – note the proximity of adjacent existing houses). Impact rolling was undertaken in May 2004 (Figure 4).

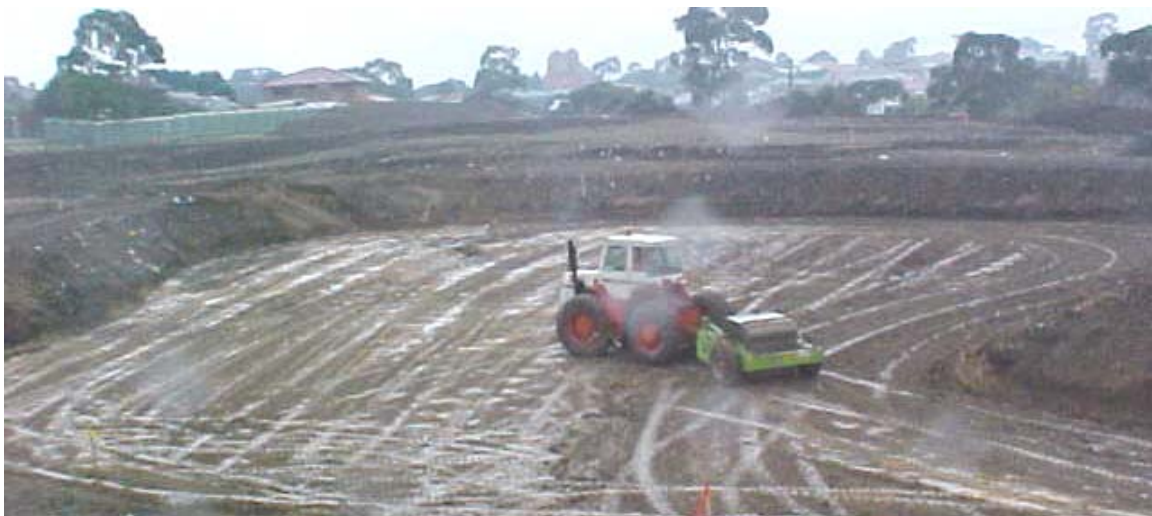
Figure 4. Impact rolling underway.

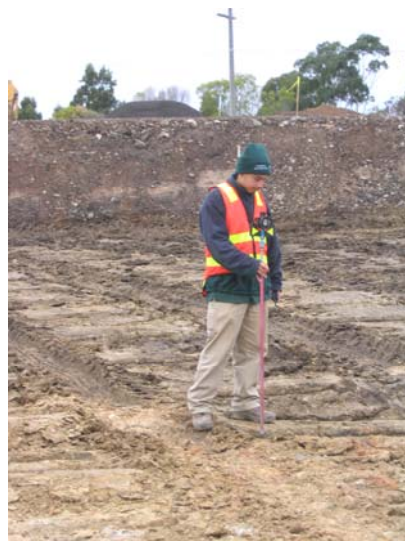
Figure 5. Monitoring of surface settlement during impact rolling.

Settlement monitoring was utilised to demonstrate the “effective refusal” specification. A total station was set up off the rolling surface and every few passes, the surface level was measured on a 10m grid, as illustrated in Figure 5.

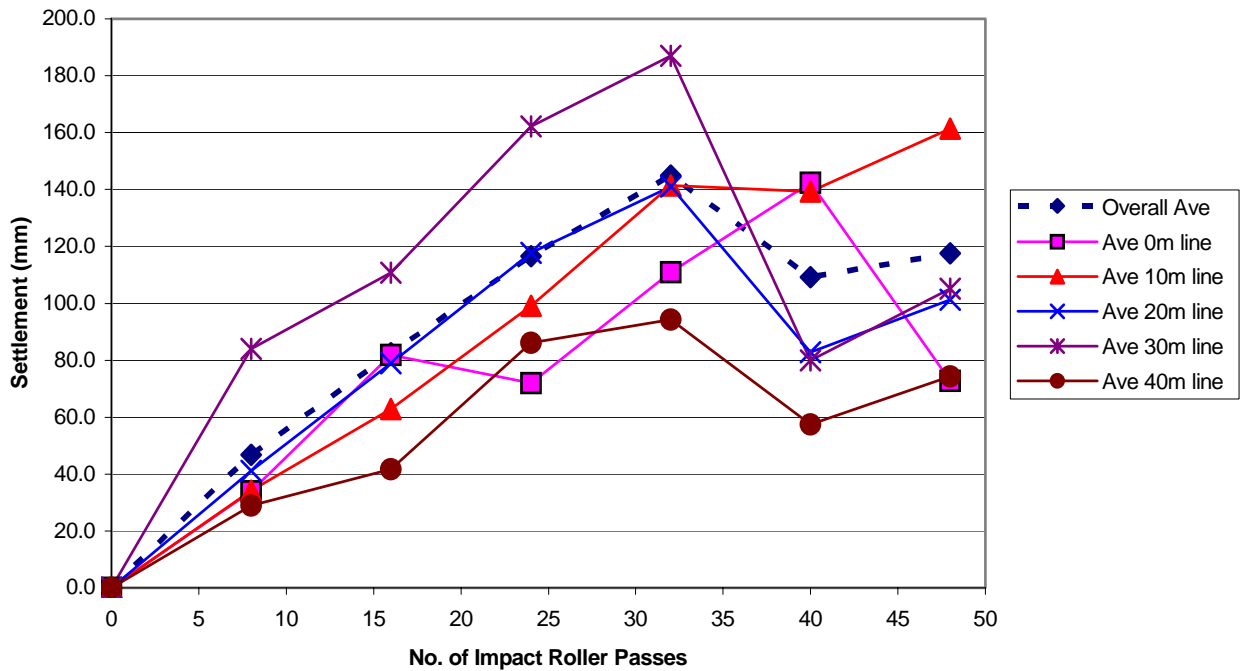
Figure 6. Average settlements occurring during impact rolling.

The results of the surface settlement monitoring showed an overall average settlement across the whole site of almost 120mm, with a maximum settlement of 492mm at one location and a heave of 42mm at another point. Figure 6 illustrates the overall average settlement, as well as the average settlement on five grid lines running across the site.

While the overall average settlement was used to verify “effective refusal”, the graphs along the grid lines illustrate the differing response across the refuse fill area. The apparent reduction in average settlement at some points on the graphs may be a “rebound” phenomenon reflecting the type of waste material, or it may reflect local heave and variations in the surface level at measurement points due to the impact rolling.

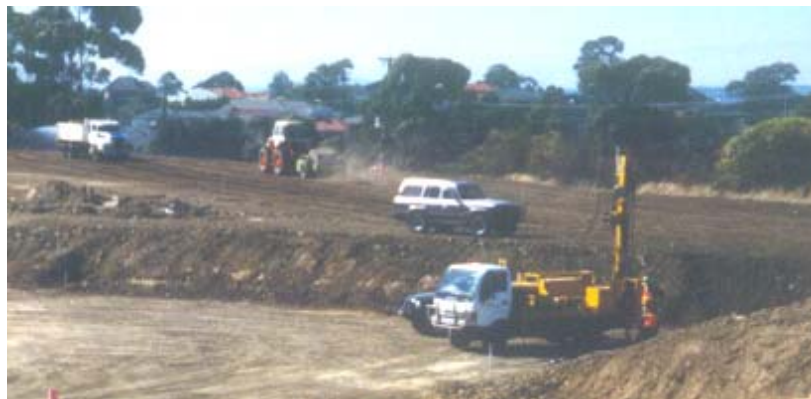
Figure 7. Field testing over the refuse fill prior to impact rolling. Impact rolling in progress on peripheral fill.

The scope of field testing before impact rolling included trial pits and boreholes. Figure 7 illustrates drilling in progress over the refuse fill zone, with impact rolling in progress on the adjacent area of quarry overburden fill. Because of the granular and heterogeneous nature of the refuse, it was not particularly suited to Standard Penetration Tests, and only 3 were carried out, providing “N” values of 8, 23 and refusal in the seating depth.

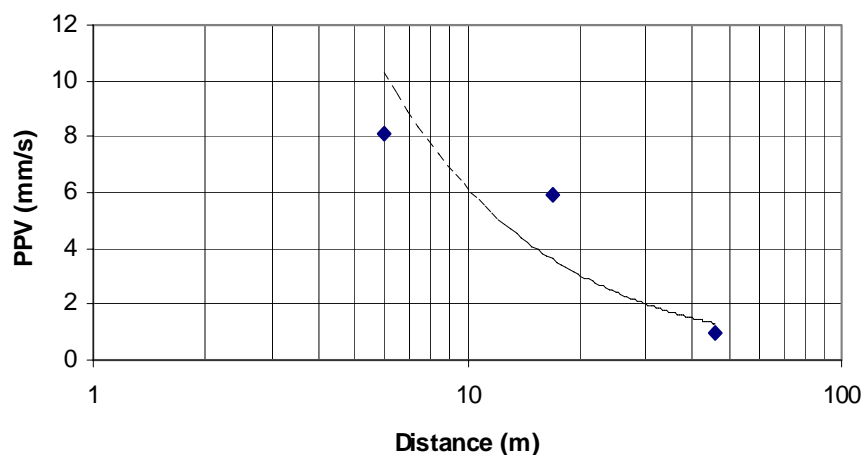
Figure 8. Maximum readings of peak particle velocity (PPV) due to impact rolling at the Greensborough site.

On commencement of impact rolling, Terrock Consulting Engineers carried out vibration monitoring at the site boundary, particularly with respect to the nearby residences. The results are illustrated in Figure 8. Based on these results, it was concluded that the nearest residence was likely to experience a maximum peak particle velocity of 2-4mm/s for the isolated occasions where the impact roller approached the closest boundary (while working on the peripheral fill).

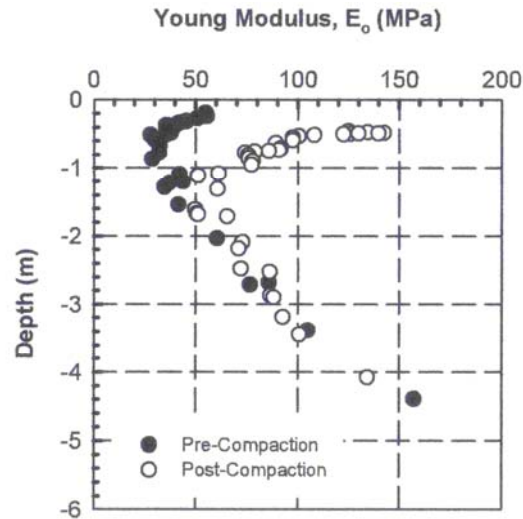
Figure 9. Typical output from CSWS testing at the Greensborough site.

Output from these tests is a profile of modulus with depth, as illustrated in Figure 9. At this particular location, an improvement to a depth of approximately 2m is evident, including the upper capping zone and the refuse fill. The results of CSWS testing provide a non-intrusive response and are suited to assessing ground improvement and strength gain, in this case due to impact rolling. A more detailed examination and discussion of these results is to be presented in a separate paper (Bouazza and Avalue, 2006).

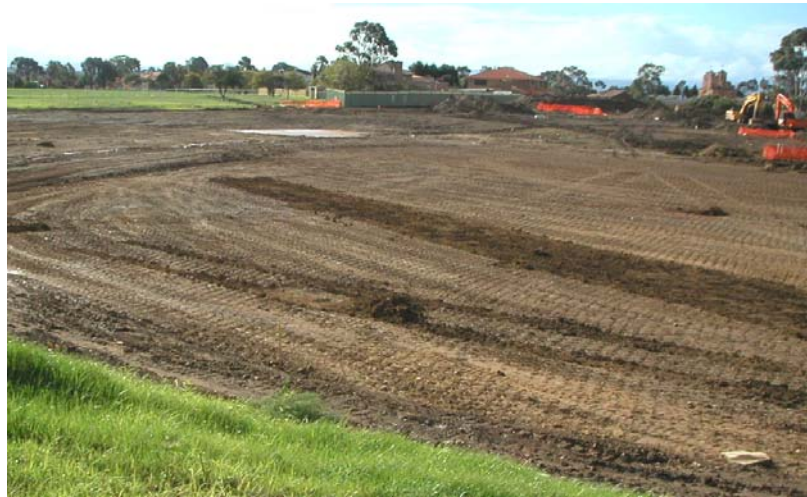
Figure 10. Completion of the capping over the refuse area.

Compaction of the capping over the refuse area (see Figure 10) was completed with conventional equipment to achieve at least 98% standard compaction and moisture contents within 2.5% of standard optimum. On average, the depth of the engineered fill was 2.07m. Further material was then placed over the refuse fill area to achieve design levels, and the eventual total thickness of material overlying the waste was 2.8-3.5m.

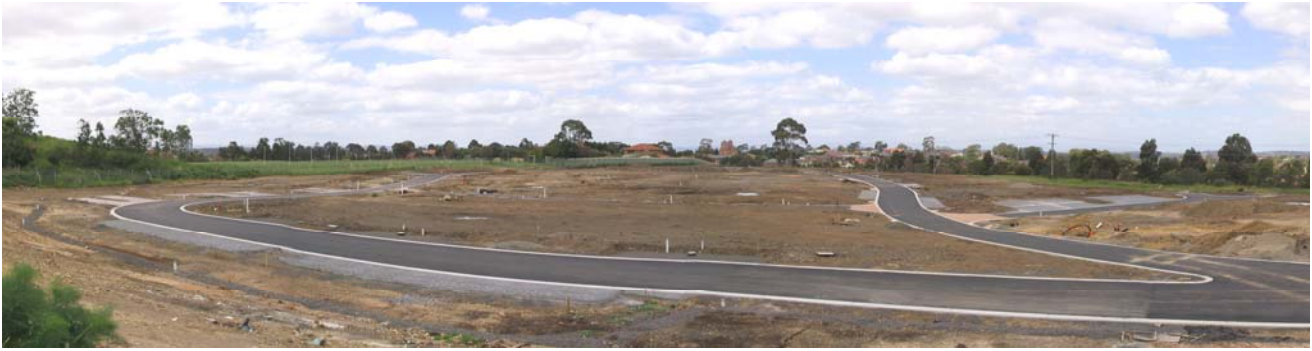
Figure 11. Earthworks, roads and drains nearing completion.

Although the site classification remained Class P in terms of the residential footings code, AS 2870-1996, the ground improvement and controlled earthworks undertaken on this site enabled footing design parameters to be developed that will facilitate building construction on engineered design shallow footings. Figure 11 shows the site in the final stages of infrastructure preparation.
