Use of the Impact Roller in Site Remediation and Preparation for Heavy Duty Pavement Construction

Mark Davies and Neil Mattes, URS Australia Pty Ltd, and

Derek Avalle, Broons Hire (SA) Pty Ltd

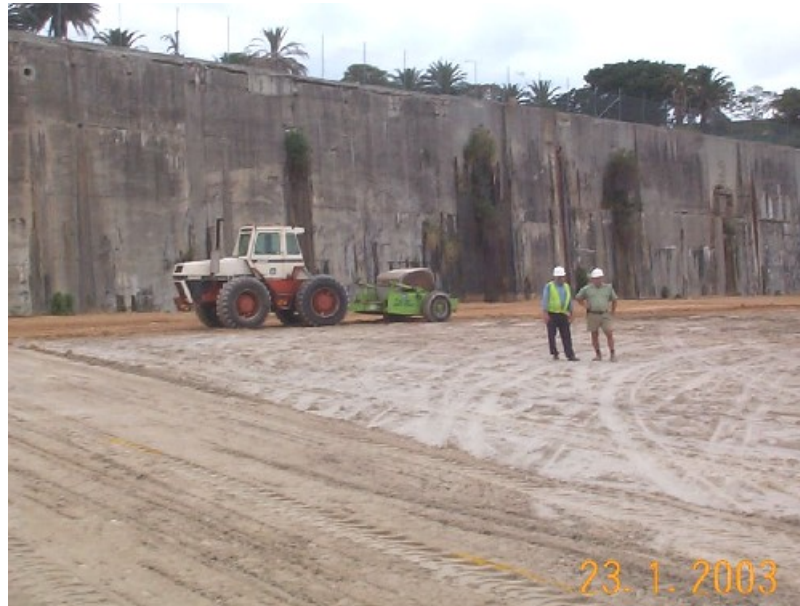
On advice from Broons, the adopted procedure for each sub-area being treated was for the impact roller to travel in progressive clockwise, then anti clockwise, patterns in north-south and east-west directions at a constant speed of approximately 12 kilometres per hour. Figure 1 shows the site during impact rolling.

Figure 1: Impact Rolling in progress at the Bunnerong Site.

On the basis of the specified total potential energy input of 240 kJ/m², the Contractor adopted 30 passes of a Broons BH-1300 impact roller. A grader was used to “smooth” the compactor indentations and tyre tracks in the running path of the impact roller every few passes.

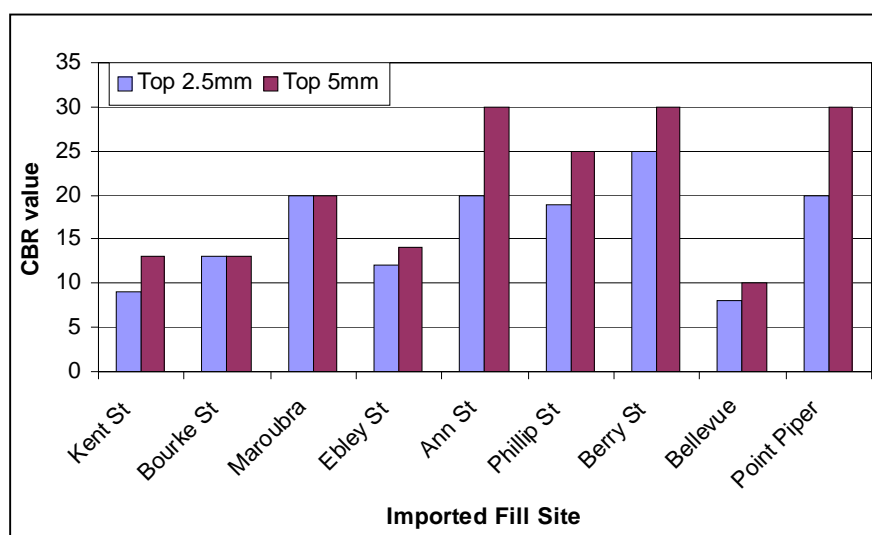
The results from the laboratory CBR tests for each of the 10 fill sites carried out by the Contractor are presented below (Graph 1).

Graph 1: Summary of CBR Test Results for each fill site.

Note that the CBR testing was carried out in the laboratory, on samples compacted to 95% DDR, 2% dry of optimum, as part of the specification requirement for fill material.

While there is no direct theoretical correlation between elastic modulus (which is a deformation parameter) and CBR (which is a strength parameter), the approximate relationship $E \text{ (MPa)} = 10 \times \text{CBR}$ is often used for subgrade evaluation. For the sandy capping material, where the moduli interpreted from the deflectometer testing were mostly in the range 120-170 MPa, this would infer a compacted CBR of 12-17, which agrees quite well with the laboratory test data summarised in Graph 1.

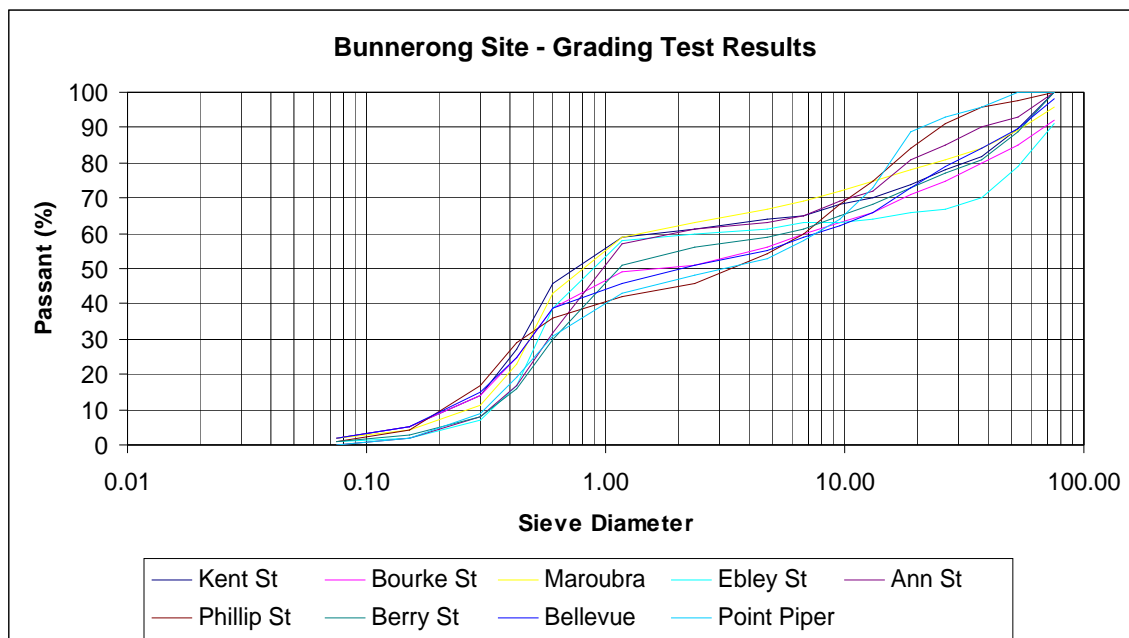
The results from the grading tests carried out by the Contractor are presented below (Graph 2). Grading curve results are displayed by the graph for locations scattered across the site by the location of each fill site's material.

Graph 2: Grading Curves for each fill site.

The Contractor had difficulty sourcing material with greater than 10% fines and it was agreed that this aspect of the specification would be relaxed. Grading curves of the materials supplied have been provided in Section 5.3.

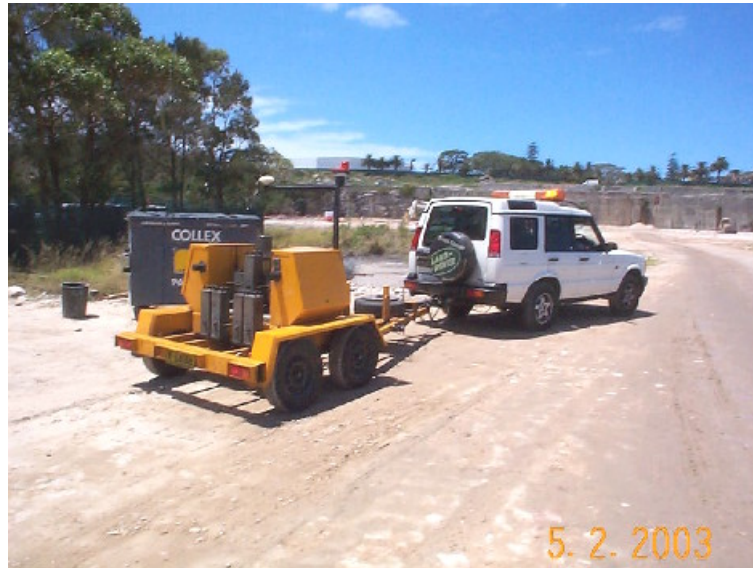
The HFWD is a trailer-mounted device which uses a falling weight to apply a load to the surface of a pavement, with the resulting pavement vertical deflections being measured by an array of transducers. The test data is analysed using a two-layer elastic model to assess the elastic moduli which give the best fit to the load/deflections measured at each point.

The HFWD can also be interpreted to produce data which is analogous to the Benkelmann Beam test for pavement deformation characteristics. The HFWD test rig is shown in Figure 2.

Figure 2: HFWD Test Rig at Bunnerong Site.

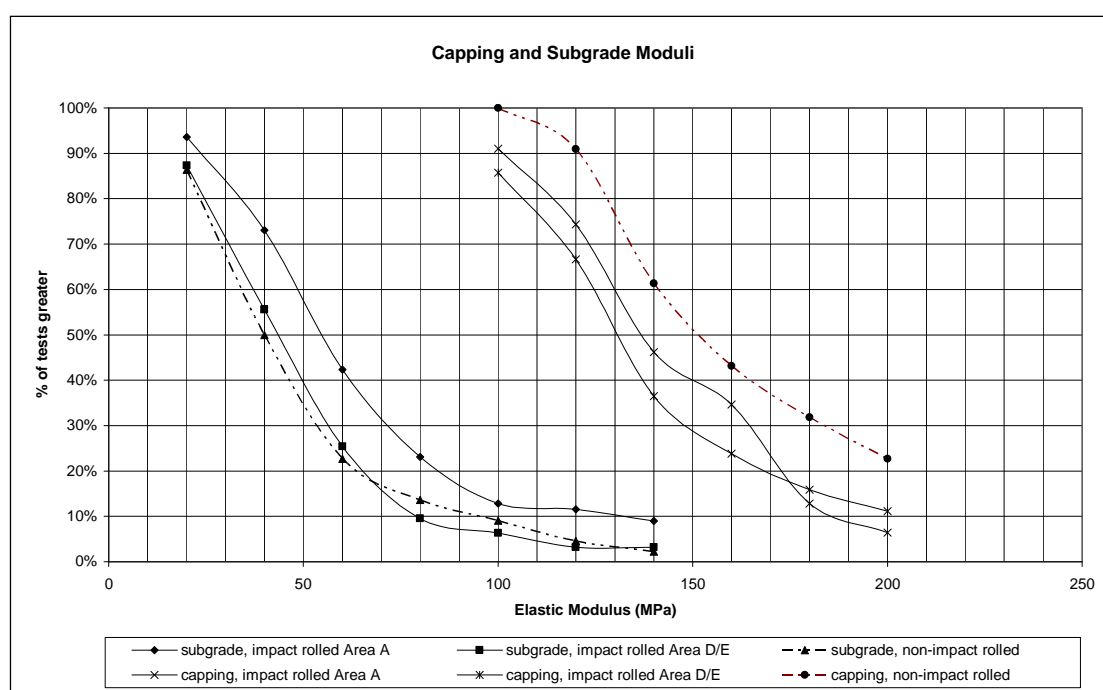
The interpreted elastic modulus data is summarised in Graph 3 below, where the y ordinate plots cumulative percentage of tests with a modulus greater than the x ordinate value. This is therefore a simplistic “confidence level” plot: for example, for the non impact rolled areas, the modulus for the subgrade at 75% of locations was at least 25 MPa, and at 50% of locations was at least 40 MPa.

Graph 3: Capping and subgrade layer moduli test results.

The deflectometer was seen as a means of economically carrying out non-intrusive tests at a large number of locations distributed across the site. The intention has been to obtain data which gives an indication of the range and variability of subgrade conditions likely to be encountered, to assist in the planning of future site usage and the design of pavements and near-surface footings. However, in the detailed design of such elements the test data in their immediate vicinity will need to be specifically reviewed, rather than simply relying on the broader statistical assessments presented in Graph 3 and 4.

For the subgrade below the capping, most of the interpreted moduli are in the range 30-70 MPa, which would infer a subgrade CBR of 3-7.

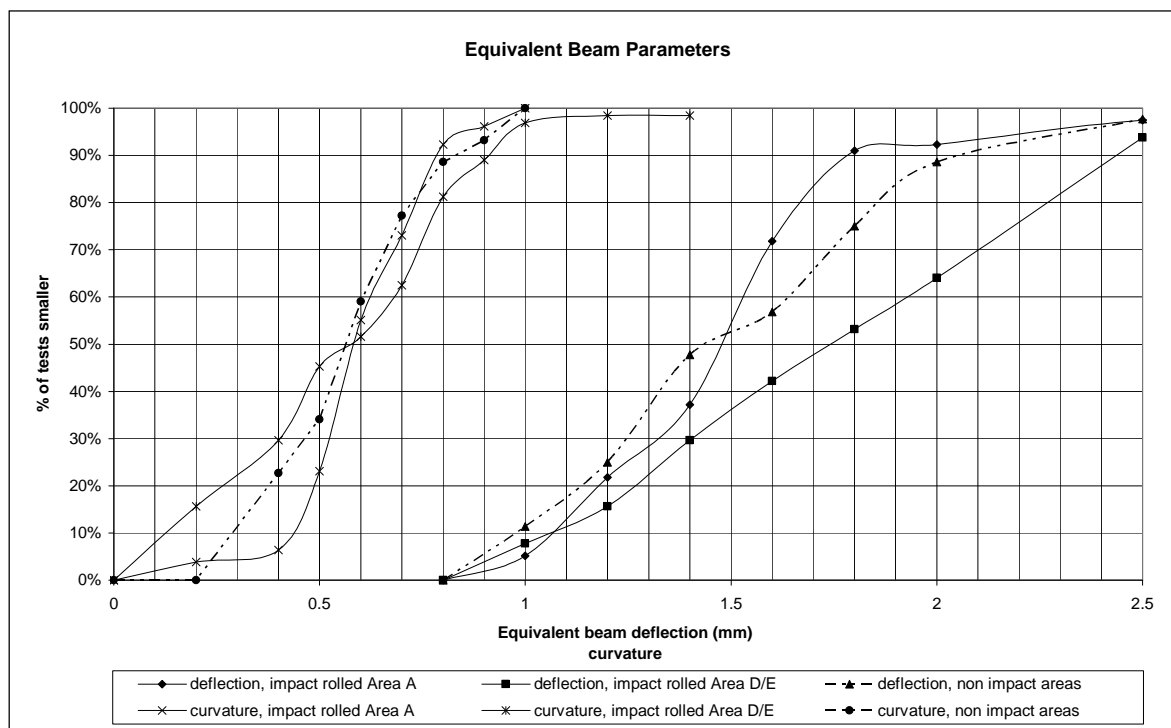
In Graph 4 below, the equivalent Benkelman Beam deflections and curvatures derived from the HFWD tests have been plotted as cumulative percentage of tests smaller than the x ordinate value. While these parameters cannot be directly used for pavement design, they may be of assistance to designers in comparing the site with their experience of other sites and conditions.

Graph 4: Equivalent Benkelman Beam parameters.
